# EVALUATION OF POLYETHYLENE SUBSURFACE DRIP IRRIGATION DRIPLINES AFTER 26 YEARS OF SERVICE IN A CORN FIELD IN NORTHWESTERN KANSAS

**Adriana Velasquez, Mark Jablonka, Freddie Lamm, Eddy Garcia-Meitin**  
The Dow Chemical Company / KSU Northwest Research Extension Center

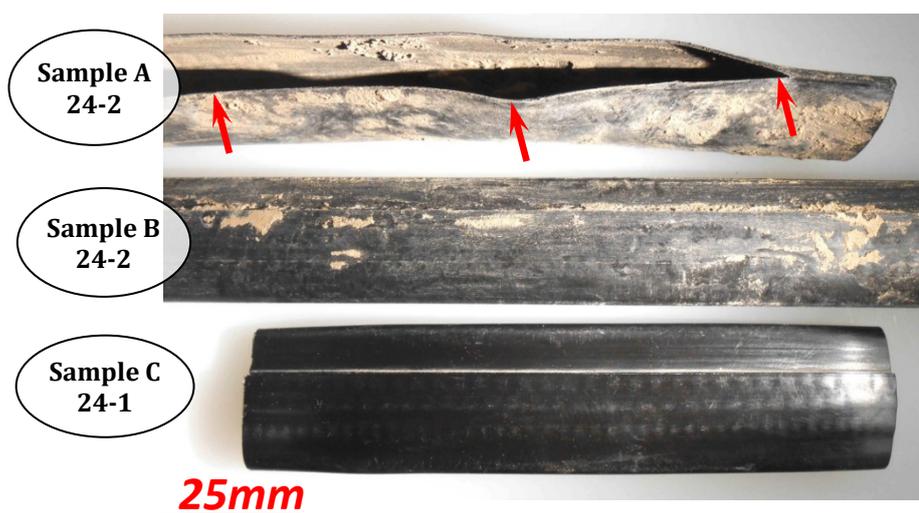
**Figure 2. As received dripline samples.**

The failed dripline was coated with dirt on both interior and exterior surfaces as received. The presence of dirt on the inside of the dripline was likely caused by either the dripline failing or being cut and removed from the field. Figure 2 is a photo of pieces of the materials received. Sample A is a portion of the failed dripline that was split. A sharp linear failure occurred along one of the two edge creases indicated by the red arrows in the photo. This failure is a machine direction split in the dripline. Sample B is a portion of the failed dripline that did not contain a failure and sample C is the control dripline which was manufactured back in 1989 but was never put in service, instead it was stored for 26 years.

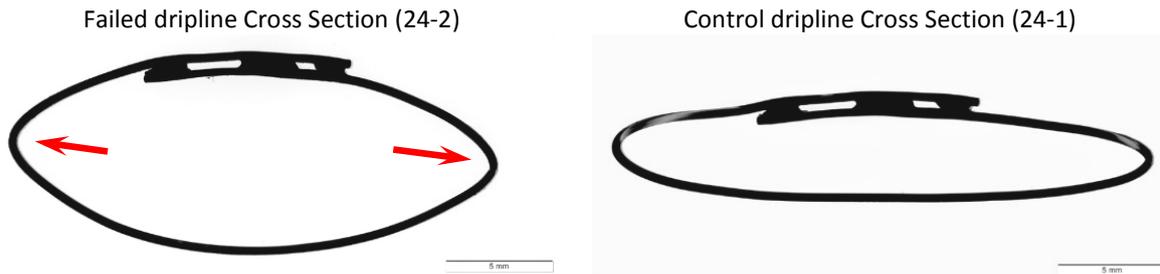
**Figure 5. Cross sections of failed and control dripline samples.**

Although dripline failures occurred along a crease the overall dripline remained pliable and visual evidence of degradation did not exist<sup>12</sup>. Figure 5 includes a cross section of the failed dripline along with a cross section of the control dripline used, with the red arrow indicating where the dripline failed. This area is where the dripline is creased as it is rolled onto the spool after being fabricated. It remains on the spool in a collapsed state until it is installed in the field.

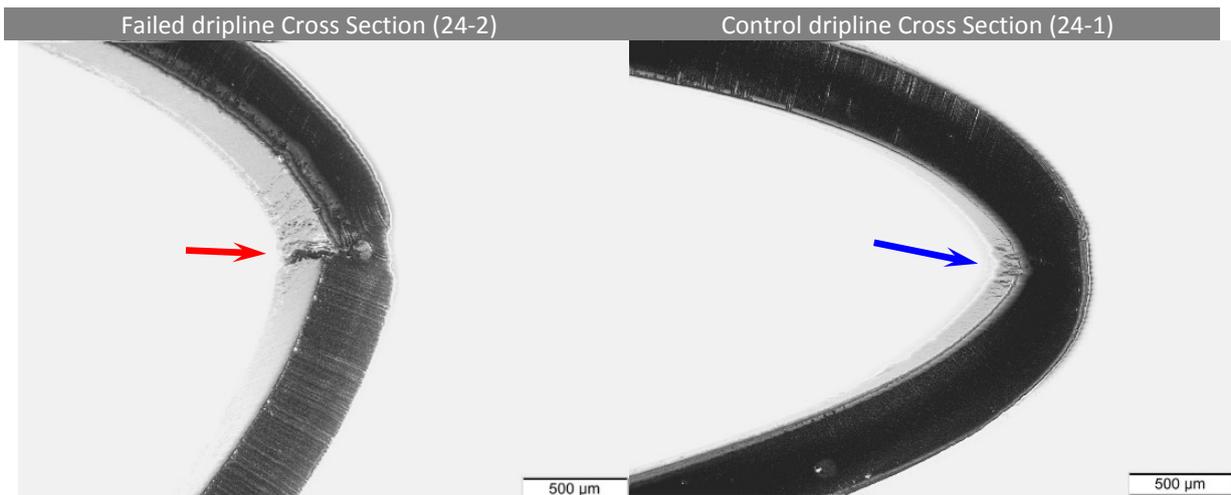
**Figure 6. Cross sectional optical microscopy images of failure region in both Failed (24-2) and Control (24-1) dripline Specimens.**

Figure 6 contains dripline cross sectional optical microscopy images taken at the failure region of the dripline. Surface striations were present along the inner surface of a control dripline which followed edge creases (blue arrow). These inner surface striations acted as crack initiation sites for the failures as shown by the internal cracks (red arrows) in the failed in-service dripline.

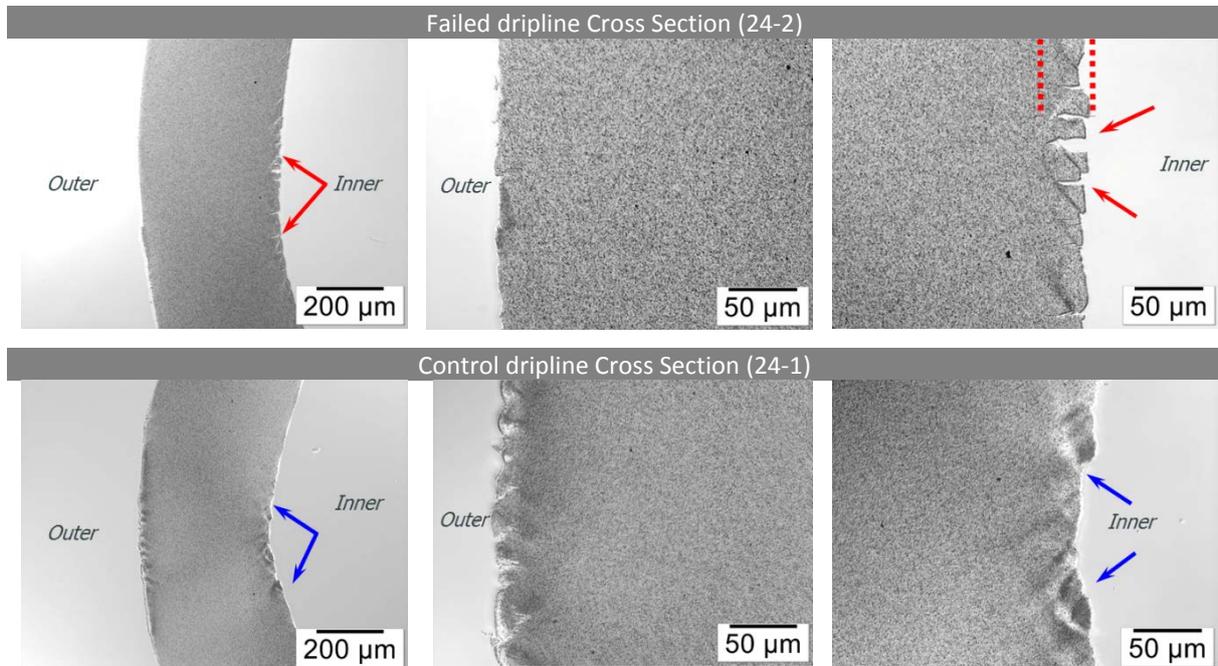
**Figure 7. Cross sectional optical microscopy images of failure region in both failed (24-2) and control (24-1) dripline specimens**

Figure 7 contains higher magnification views of the cross section of the failure region of both the failed and control driplines. Surface striations were present along the inner surface of a control dripline which followed the edge crease (blue arrows). Outer surface deformations

were also observed in the control dripline. Sharp internal cracks (red arrows) were present on the inside surface of the failed dripline in the crease region, but not on the outside surface of the dripline. Crack penetration was approximately 40um along the inner dripline surface.

A review of cross section images shown in Figure 7 and Figure 8 indicate remarkable level of carbon black dispersion and homogeneity by today's standards in dripline material used.

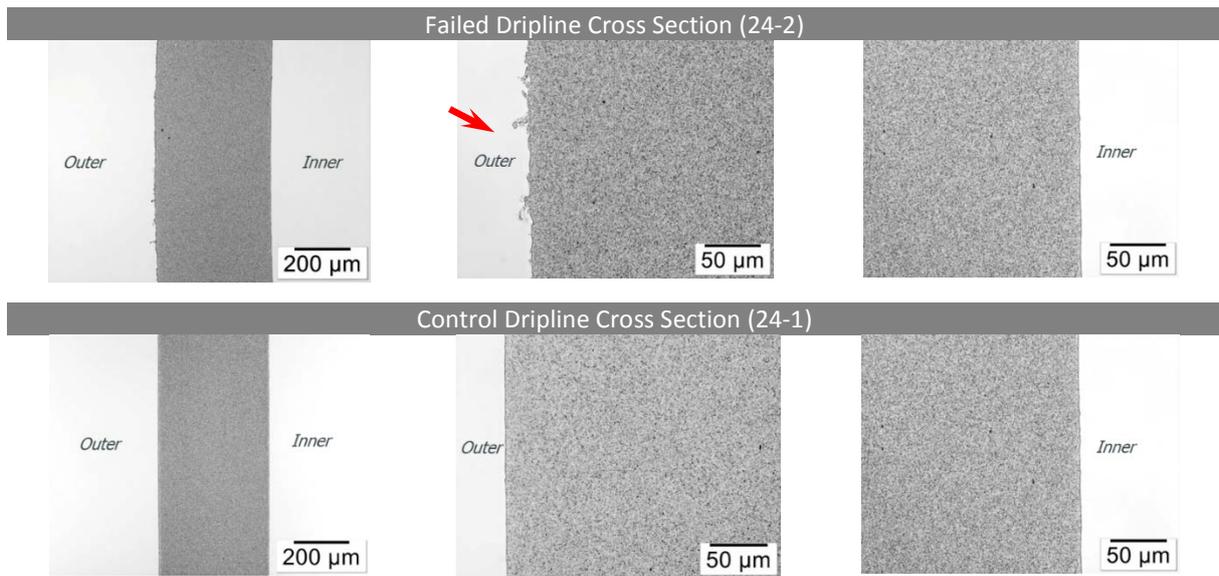
**Figure 8. Cross sectional optical microscopy images of flat (non-failure) region in both failed (24-2) and control (24-1) dripline specimens**

Figure 8 contains cross sectional images of the flat region of both failed and control driplines. The internal surface of both the failed and control driplines in areas away from the crease were absent of any striations, cracks or defects, suggesting the strain in the crease area coupled with exposure to the liquid medium pumped through the dripline over the years led to the failure of the dripline in the failed dripline sample which is expected. Evidence of dripline degradation or cracking was not observed in areas away from the crease. Prior studies have shown an increase in the rate of degradation of polyethylene when a constant strain has been applied.<sup>v</sup> Slight abrasion was observed (indicated by red arrow in Figure 8) along the outer surface of the failed dripline, but is not present on the inner surface of the failed dripline. This abrasion likely occurred during the installation of the dripline because it is not present in the control dripline. There was no evidence of failures initiating from the slightly abraded surface of the failed dripline. This abrasion must have occurred during installation or normal use over time.

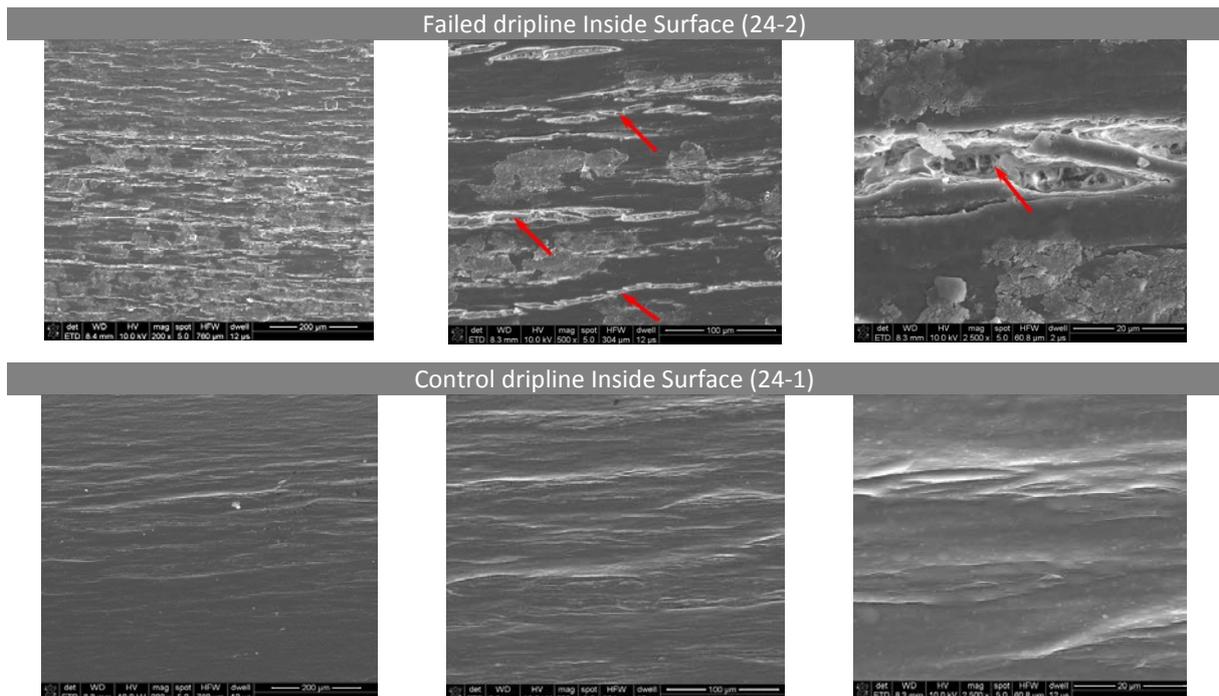
**Figure 9. SEM Images of Inner Surface of Crease Region in both Failed and Control Dripline Specimens.**

An evaluation of the inner dripline surfaces showed parallel striations were present along edge creases, as shown in optical cross sections. Figure 9 contains scanning electron microscope (SEM) images of the inner surface of the crease region in the failed and control dripline specimens. Surface cracks were not observed along creases in the control dripline. Sharp parallel cracks (red arrows) were present along the creases of the failed dripline.

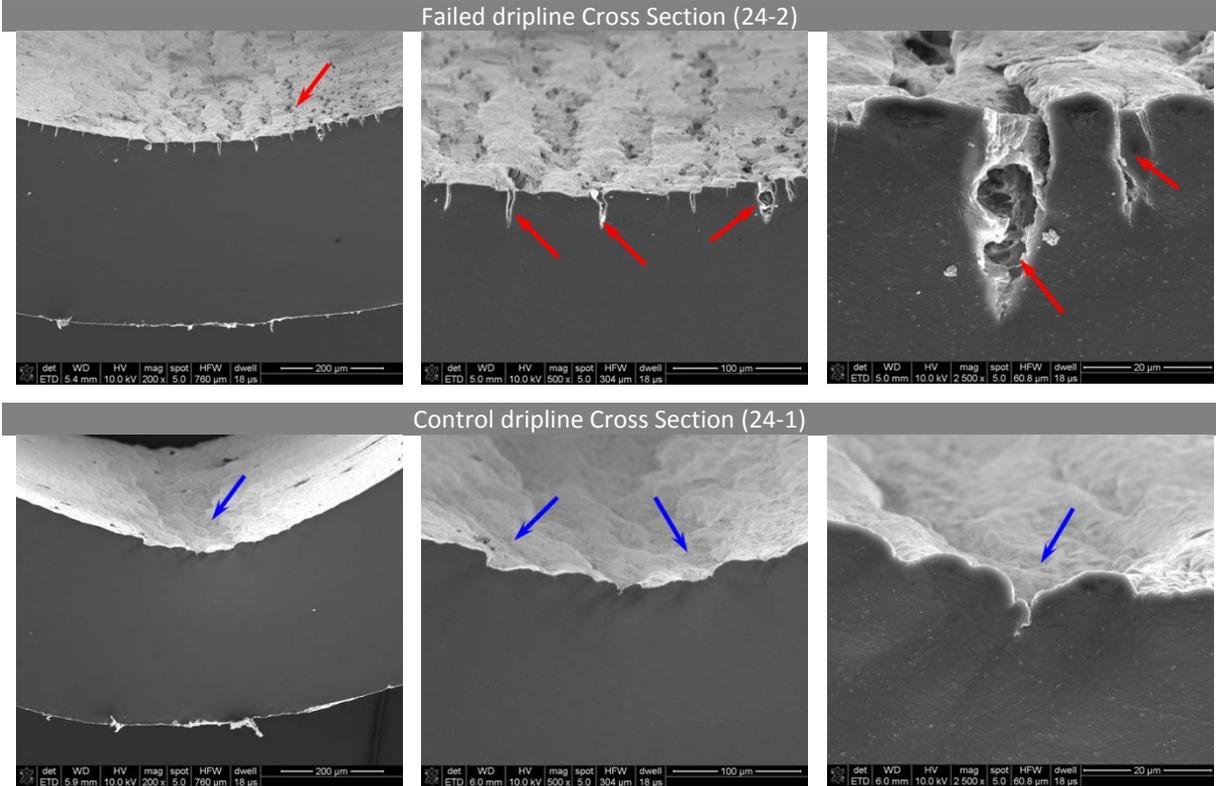
**Figure 10. SEM cross section images of crease region.**

Comparison of the inner surface of the crease region of the dripline using SEM shows the surface striations present in the control driplines, shown in Figure 10 and highlighted with blue arrows. The cracks on the inner surface crease region are also shown in the failed dripline (red arrows), with cracks penetrating approximately 40um into the wall of the dripline.

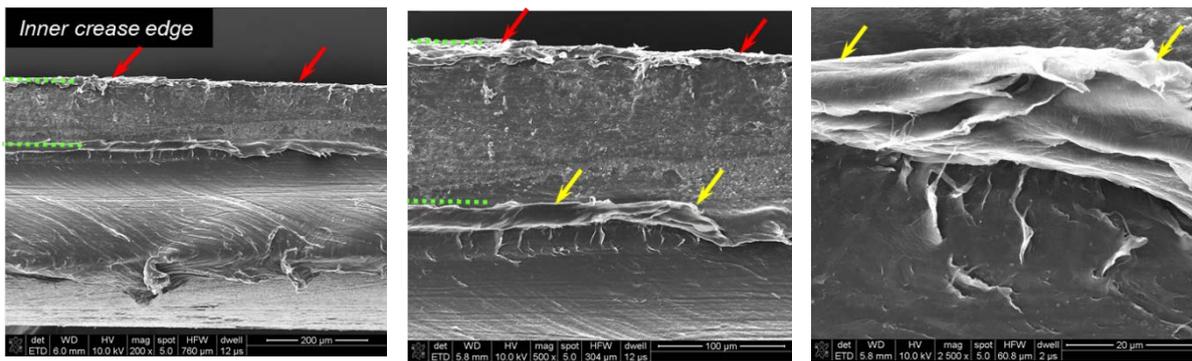
**Figure 11. SEM Images of fracture surface along crease of failed dripline (24-2)**

Examination of a fracture surface of the failed dripline showed that failure had initiated at the inner surface of the crease, inside the dripline, and propagated outward. The red arrows in Figure 11 indicate where the fracture initiated. A fracture surface associated with brittle failure was observed to a depth of approximately 125um or 5 mils (indicated by the area between the green dotted lines). This region was associated with parallel striations which formed sharp linear surface cracks along the dripline crease. Beyond the initial brittle fracture, a ductile shear lip was present (indicated by the yellow arrows in Figure 11) which extended to the outer dripline surface. Evidence of ductile tearing was observed beyond the initial brittle fracture zone.

It is noted that the fracture surface was found to be extremely brittle, as shown in Figure 11, and it is therefore unlikely any antioxidants were present in this brittle area. The material in the crease region had reached stage 3 of the classical chemical degradation model for polyethylene, the stage at which all antioxidants are depleted, chemical degradation of the polymer is occurring, ultimately leading to an engineering failure.<sup>vii</sup>

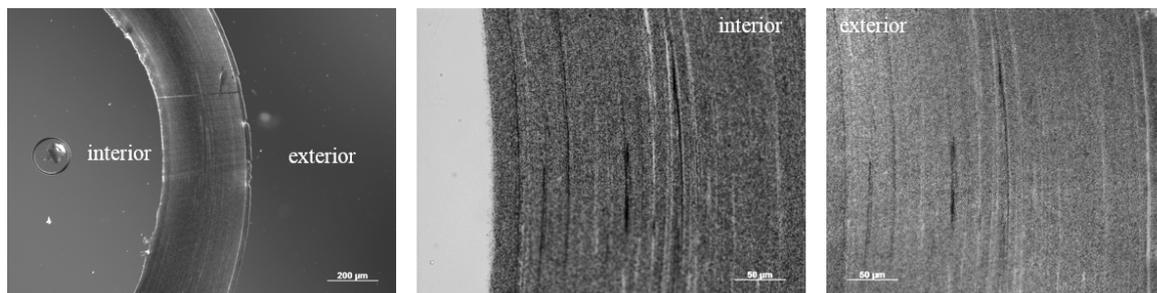
**Figure 12. Cross sectional optical microscopy images of Dripline made in 2017 with 100% Dow FINGERPRINT™ Resin**

Analysis of a dripline manufactured in 2017 with Dow's FINGERPRINT™ resin was done. The results are shown in Figure 12 below. The pictures show that the dripline does not have striations on the crease, there is no evidence of manufacturing deficiencies. Therefore the striations observed on the 26 year old dripline which initiated the failure likely appeared over time due to the depletion of the AO and localized compressive stress in the fold area during its lifetime. That is why the control tape also presented the striations, but didn't fail due to the fact that was not in use. This is the same issue any collapsible/folded tape would have.
