# Treatment of SDI Emitters Clogged with Manganese Compounds

**Abstract.** *Dissolved manganese in irrigation water has contributed to emitter clogging of subsurface drip irrigation (SDI) systems in the Texas High Plains. During the 2002 growing season, areas of clogged emitters occurred in a 16-acre research field at the Texas AgriLife Research and Extension Center at Halfway, Texas. Water samples from the irrigation source were analyzed and SDI emitters in the affected areas were uncovered and examined in a laboratory setting. Evaluations indicated clogging was caused primarily by manganese oxides deposited inside SDI laterals and emitters. Observations of reactions of manganese compounds with combinations of acids and hydrogen peroxide ( $H_2O_2$ ) resulted in a protocol that dissolved these oxides in open laboratory containers. Further tests examined pressurized sections of excavated, clogged SDI laterals with  $H_2O_2$  / acid solutions for periods of up to 96 hours. This exercise led to the successful field treatment that cleared clogged emitters at the research site. Continued maintenance of the research system involved the injection of 2.5 ppm  $H_2O_2$  in slightly acidic

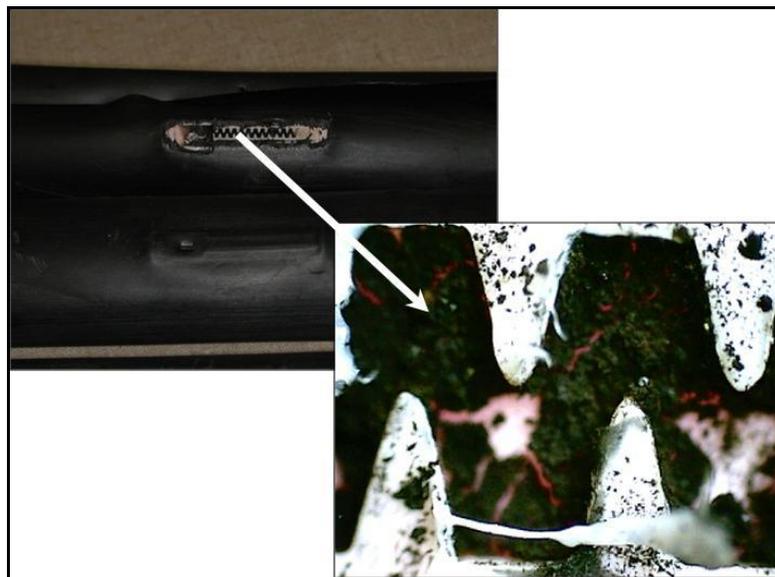
In the summer of 2002, SDI emitter clogging caused severe drought stress to cotton plants in areas within a 16-acre research field at the Texas AgriLife Research Center, Helms Research Farm at Halfway, Texas. Irrigation zone flow rates were near the design rates in September 2001 and during initial pre-plant irrigation in 2002, however they soon declined. Further investigation and analysis of residue and water samples by the Soil, Water, and Forage Testing Laboratory (Texas A&M University, College Station, TX) led to the conclusion that the primary constituents causing emitter clogging were manganese oxides. Figure 1 shows drip laterals and clogged emitters removed from the problem SDI field.

Figure 1. Clogged SDI emitters removed from research test plots at the Texas AgriLife Research Center, Halfway, 2002.

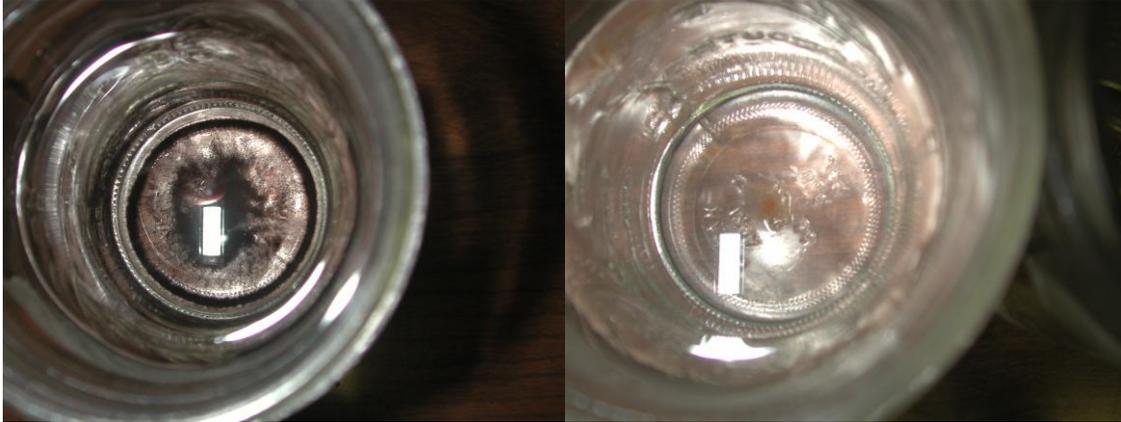
The results were promising. Figure 2 shows two jars containing 0.02 g of the Mn compound in 16 oz. of irrigation water with  $\text{H}_2\text{O}_2$  at 0.125%. The pH of the container on the left was 7.6 while that of the container on the right was 6.5. Only residual sand particles were visible in the right container as the Mn had been dissolved. The time required to dissolve the material at room temperature was within seconds.

Figure 2. Jars containing Mn at 0.15 g material/gal of irrigation water, both at 0.125% H<sub>2</sub>O<sub>2</sub> concentration. The pH of the container on the left was 7.6; the pH of the container on the right was 6.5.

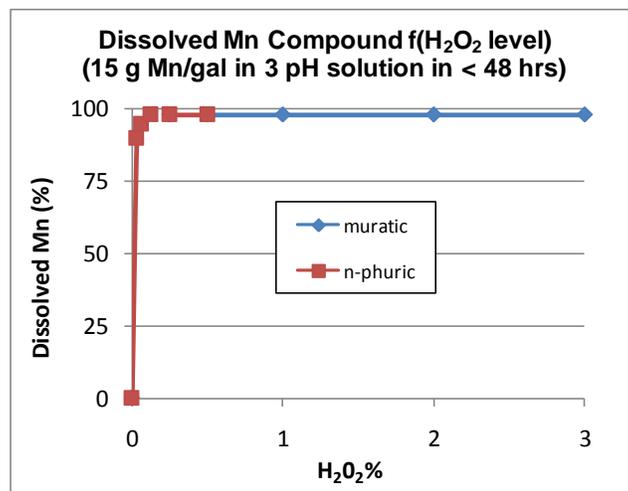
The quantity of Mn material dissolved in different solutions having H<sub>2</sub>O<sub>2</sub> concentrations ranging from 0 to 3% using muriatic acid or N-pHuric™ to lower pH is shown in Figure 3. At pH 3, 90% of the Mn compound was dissolved at 0.0312% H<sub>2</sub>O<sub>2</sub> in six hours. The acid source did not change the outcome. Due to its relative safety, N-pHuric™ (Agrium, Calgary, Canada) which contains 49% equivalent sulfuric acid and 15% of water soluble organic nitrogen was used for the remaining evaluations.

Figure 3. Percent of Mn material dissolved in solutions having H<sub>2</sub>O<sub>2</sub> concentrations of 0 to 3% using muriatic acid or N-pHuric to lower solution pH.

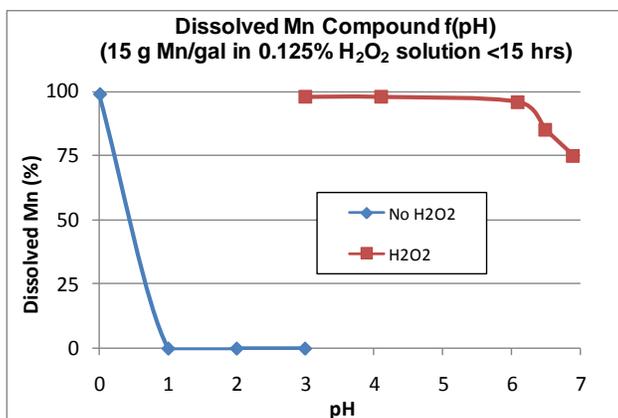
Figure 4 displays the relative quantity of Mn material dissolved in solutions having acidity ranging from 0 to 7 pH, with and without H<sub>2</sub>O<sub>2</sub>. This, as well as previous figures, show relatively small levels of H<sub>2</sub>O<sub>2</sub> dissolved the troublesome compound, but only if the pH of the solution was below 7. Acid alone was not a reasonable means for opening clogged emitters with this type Mn material.

Figure 4. Percent of Mn material dissolved in solutions having pH ranging from 0 to 7, both with and without H<sub>2</sub>O<sub>2</sub> in the solution.

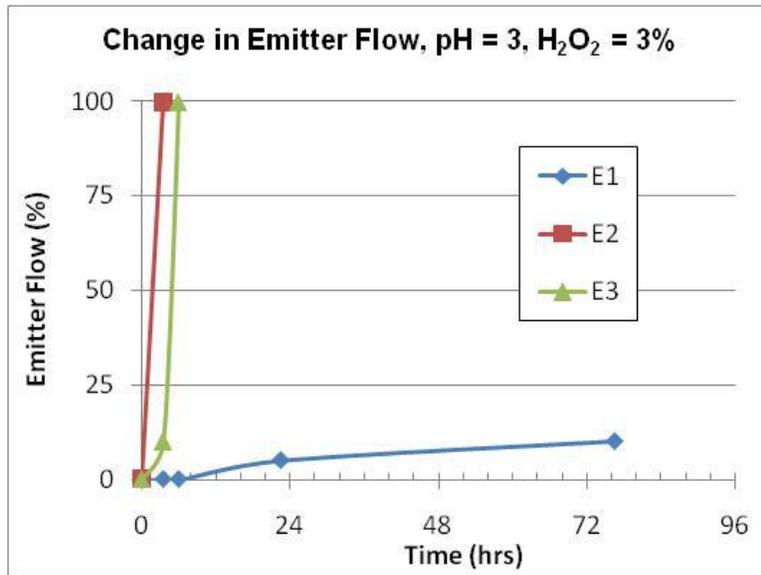
Under identical but separate treatments, two of three emitters returned to 100% design flow after 3.5 and 6 hours, respectively, when treated with 3% H<sub>2</sub>O<sub>2</sub> solution at pH 3 and pressured to 30 psi (Figure 5). Sand particles as well as additional Mn compounds were found in the third emitter after dissection following the test. Pressure effect on unclogging emitters is shown in Figure 6. Clogged emitters were treated with a 0.5% H<sub>2</sub>O<sub>2</sub> solution at pH 3 and pressurized to 12 then 30 psi versus continuous 30 psi. Immediately elevating the lateral pressure to 30 psi (emitter P3) versus starting with 12 psi then changing to 30 psi (emitters P1 and P2) resulted in full emitter flow in 4.75 hours instead of 23.5 and 33 hours, respectively. Although SDI installations are typically designed for 20 psi or less, pressure greater than standard operating pressures had major impact on the time required to open clogged emitters. The time required to open emitters was also affected by the pH and H<sub>2</sub>O<sub>2</sub> level of water forced through the emitters (Figure 7). Relative time for emitters to clear were 3.5, 20, and 78 hours from solution treatments with 0.25% H<sub>2</sub>O<sub>2</sub> at pH 3, 0.25% H<sub>2</sub>O<sub>2</sub> at pH 4.7, and 0.5% H<sub>2</sub>O<sub>2</sub> at pH 4.7, respectively with pressure at 30 psi. For these three emitters, elevated pH and reduced H<sub>2</sub>O<sub>2</sub> levels increased time for full flow. In all evaluations, once initial flow started, emitters typically cleared within a few hours.

Figure 5. Relative emitter flow over time of three random clogged emitters treated with 3% H<sub>2</sub>O<sub>2</sub> solution at pH 3 and pressurized at 30 psi.

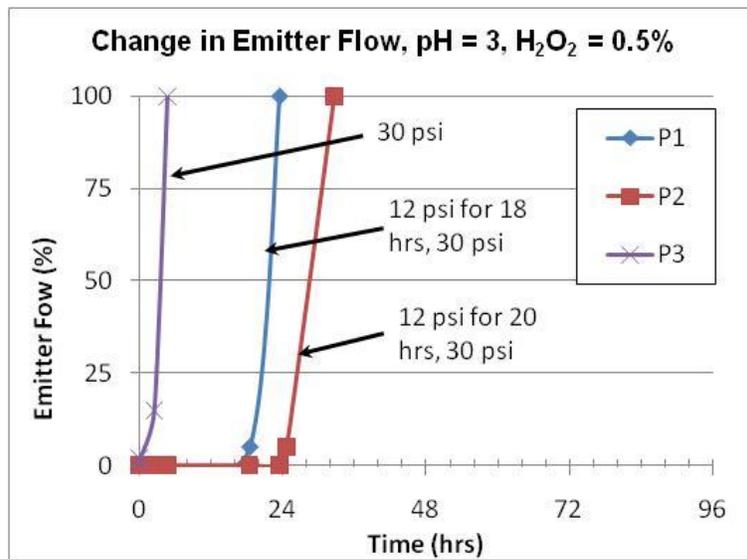
Figure 6. Relative emitter flow over time of three clogged emitters treated with a 0.5% H<sub>2</sub>O<sub>2</sub> solution at pH 3 and pressurized to 12 then 30 psi versus continuous 30 psi.

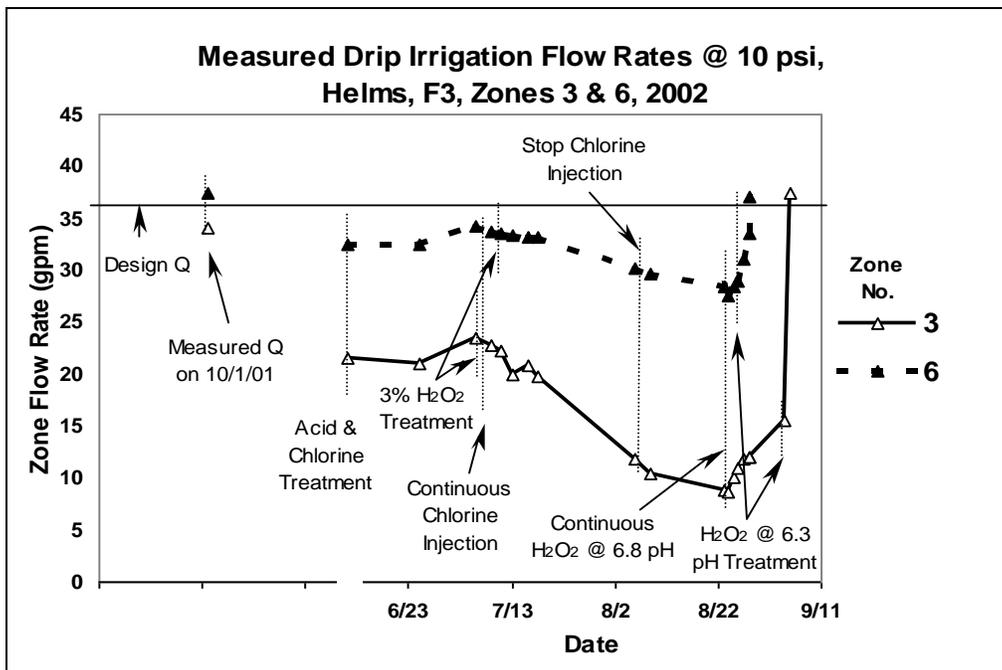
Figure 8. Flow rates and treatment events of a severely clogged zone (Zone 3) and a less severely clogged zone (Zone 6) from May until full emitter flow was reestablished in September, 2002.

The general procedure used at the Texas AgriLife Research and Extension Center, Helms Research Site, Halfway, Texas to open SDI emitters clogged with manganese oxide compounds was:

- 1) Several drip lateral sections with adjacent clogged emitters were uncovered in the zone to be treated. Water from the zone was drained and sections of drip lateral containing clogged emitters were replaced with lateral sections having new emitters

with the design flow rate. During the cleaning process, differences in flow rates of the adjacent new and clogged emitters were monitored to determine the effect of the process.

- 2) The pH of irrigation water was lowered at the well to 6.3 using N-pHuric™.
- 3) Drip laterals in the target zone were flushed with filtered water until clear.

- 4) With the flush valve open, H<sub>2</sub>O<sub>2</sub> was injected prior to filters at a rate resulting in a 0.1% H<sub>2</sub>O<sub>2</sub> solution with this rate maintained until it reached the flush valve. The flush valve was closed; the water flow and H<sub>2</sub>O<sub>2</sub> injection stopped; and the solution left in the drip laterals overnight (16 hours).

- 5) Simultaneously zone and flush valves were opened and chemical injection restarted thereby resuming the flow of 0.1% H<sub>2</sub>O<sub>2</sub> in 6.5 pH irrigation water into each zone.

- 6) Flush water was allowed to clear before closing the flush valve and pressurizing the target zone to normal operating pressure (10 psi). The zone flow rate was recorded.

- 7) Injection rates were readjusted to maintain pH and H<sub>2</sub>O<sub>2</sub> concentrations as zone pressures were increased to 20 psi. As emitters began to open, zone flow increased and chemical concentrations adjusted to maintain desired levels. This process continued for 6 hours in Zone 3, the zone most severely clogged. Terminating this part of the process was based on evidence of emitter flow from previously clogged emitters. Hydrogen peroxide bubbles “erupted” on the soil surface above covered emitters that were not fully clogged.

- 8) After this injection period, the H<sub>2</sub>O<sub>2</sub> concentration was reduced to 2.5 ppm at 6.8 pH and 20 psi pressure for an additional 6 hours. Pressure was then readjusted to normal levels and zone flow rates recorded. Throughout this process, uncovered emitters, zone flow rates and pressures were monitored to determine the effectiveness of the cleaning procedure.

- 9) After all zones were treated, the normal operation cycle for irrigation was resumed. In all zones, flow rates recovered to the original design level.

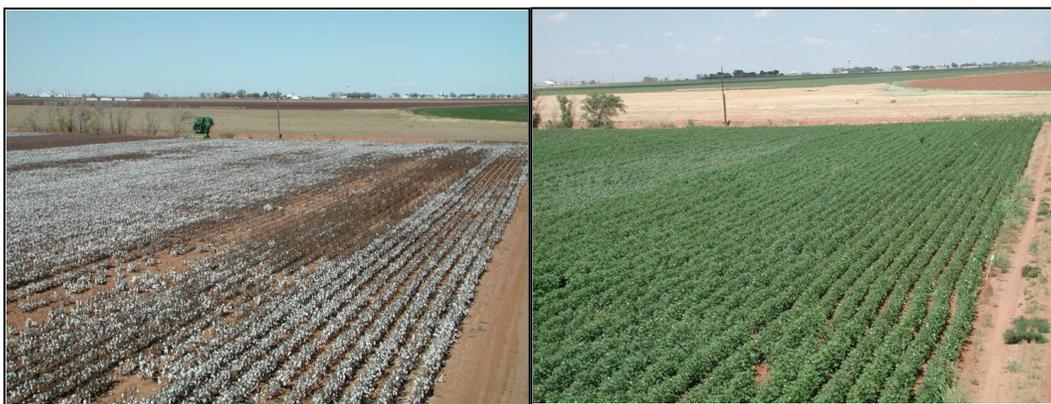
Figure 9 shows the effects of emitter clogging on cotton growth in 2002 and the result of the reclamation process at the same locations in 2003.

Figure 9. Effects of SDI emitter clogging on cotton production in 2002 (left) and cotton in 2003 at the same location following SDI system reclamation (right).

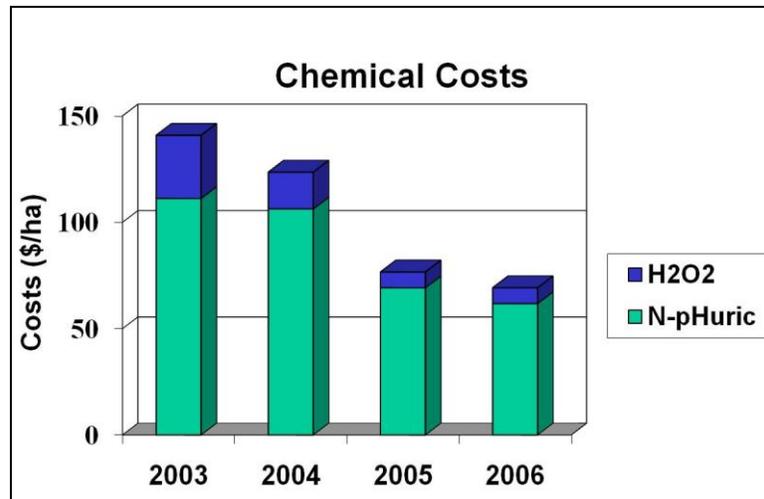
The cost of maintenance treatments from 2003 to 2006 is given in Figure 10.

Figure 10. Hydrogen peroxide and acid costs for maintenance of SDI systems at the Texas AgriLife Research Center, Helms Research Farm, 2003-2006.

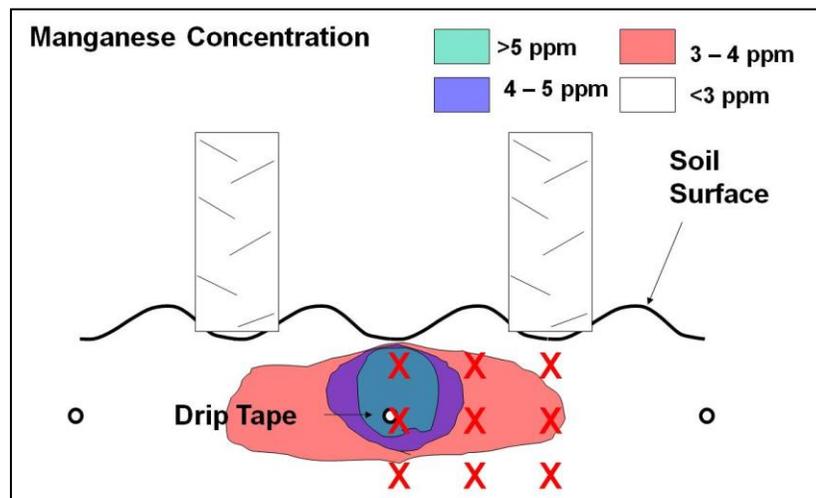
Manganese found in these soil samples ranged from <1 ppm to slightly greater than 5 ppm. Figure 11 shows soil sample locations and average residual Mn concentrations around drip laterals in treatments irrigated at approximately 80% crop evapotranspiration. Although Mn concentrations have appeared to follow SDI wetting patterns, the quantities of this element are well below toxic levels for cotton plants. Mn concentrations in the root zone have continued to be monitored with no significant increases since 2003.

Figure 11. Soil sample locations and average residual manganese concentrations around SDI laterals, Helms Farm, Halfway, TX, 2003.
