## **PROTECT STREAMBANKS WITH TREES**

**W.A. Geyer, T. Neppl, and K. Brooks\***

SRL 122

October 1998

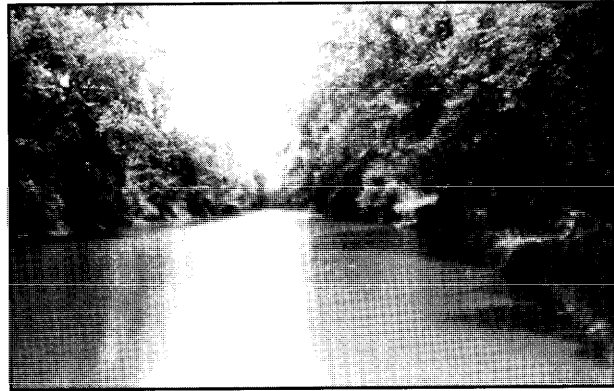
**Figure 4. Natural woody vegetation should be left to protect streambanks.**
