An ASABE Meeting Presentation

Paper Number: 162461575

Long Term Performance of a Research Subsurface Drip Irrigation System

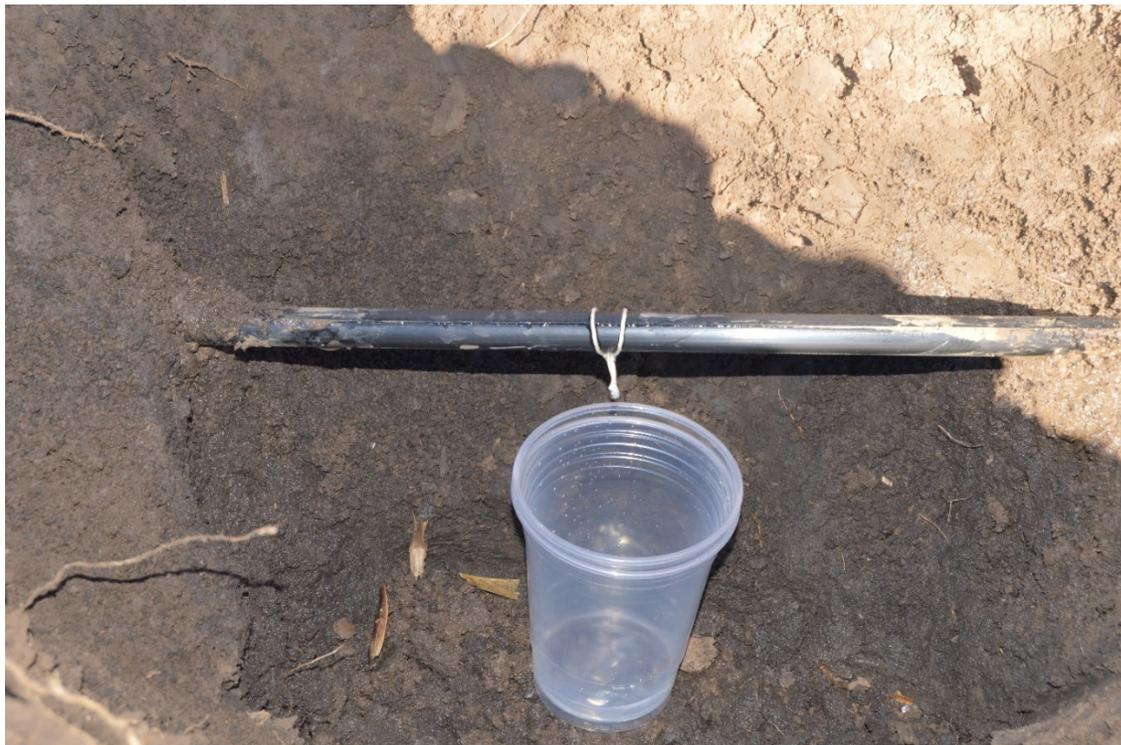
Figure 2. Arrangement for measuring emitter discharge over a 20 minute period.

38, 69 or 84 m to allow for in-situ emitter discharge and pressure measurements. The pressure at the plot inlet was standardized at 68.9 kPa for these measurements. Water was collected for a total of 20 minutes in a plastic cup within another cup placed beneath each selected emitter (Fig. 2). A short cotton string was wrapped around both sides of the emitter to direct water droplets into the cup to prevent indiscriminate flow along the dripline. After the 20 minute period the water in the inner plastic cup was weighed in the field with an electronic balance to the nearest 0.1 gm for emitter discharge calculations. Two twenty-minute samples were collected and averaged to determine the emitter discharge. Pressure measurements were measured to the nearest millibar by puncturing the dripline near the emitter with a needle tube attached to a Tensimeter brand pressure transducer (Fig. 3).

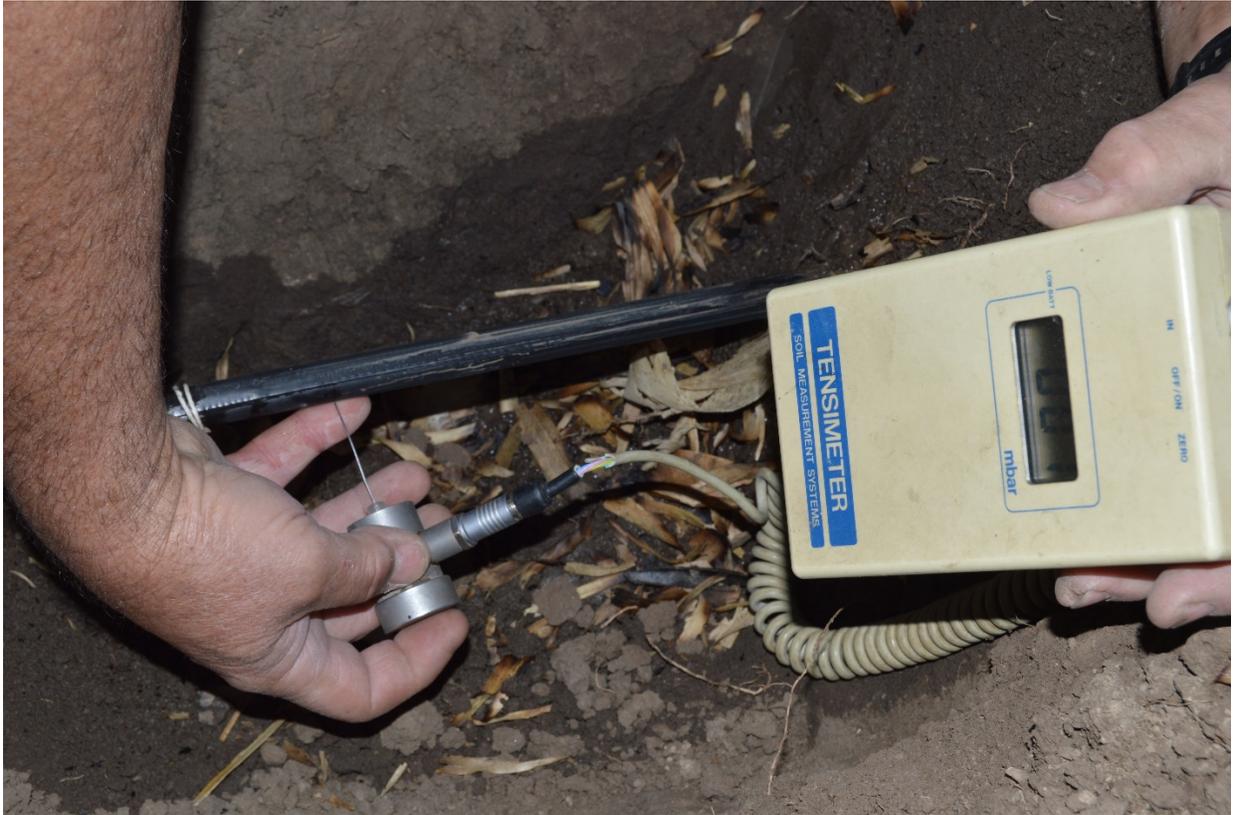
Figure 3. Measuring dripline pressure at the emitter by puncturing the dripline with a needle tube attached to a pressure transducer.

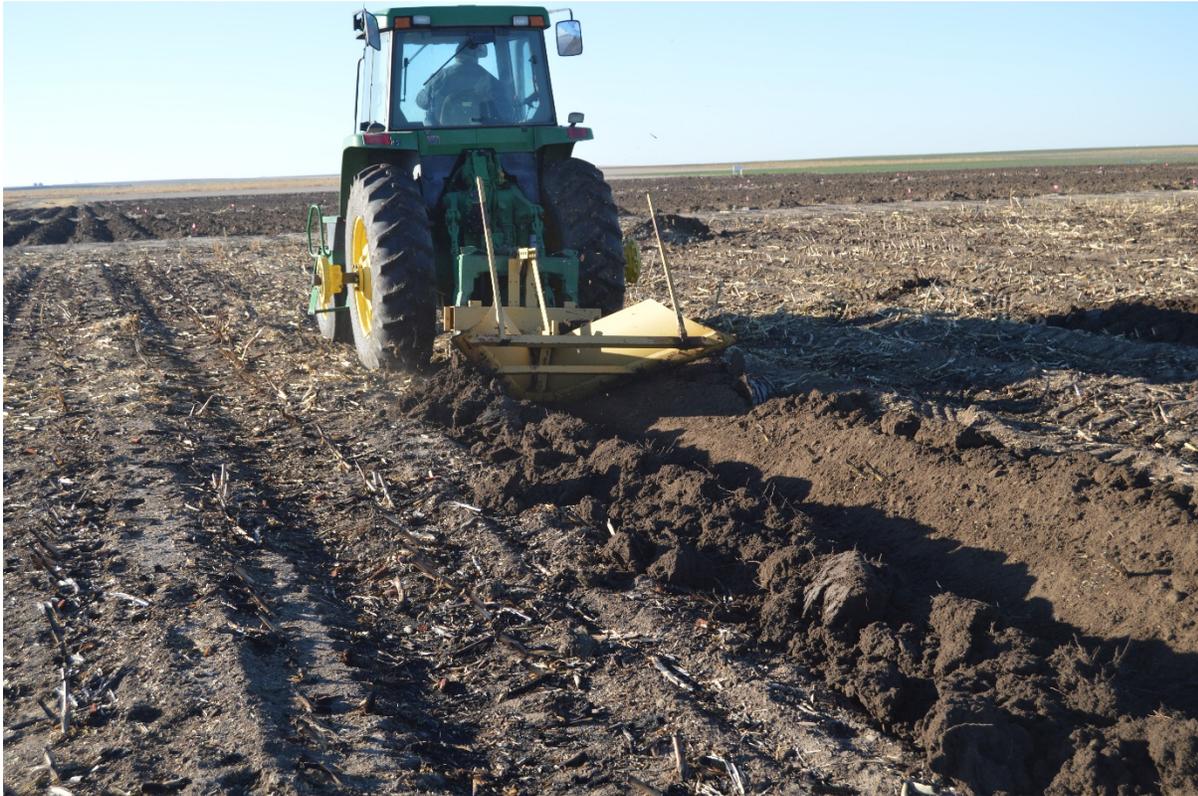
Figure 4. Excavating the overburden over driplines selected for laboratory performance measurements.

After the emitter discharge and pressure measurements at the randomized distances were made, approximately 20 m lengths of dripline were excavated from one of the center two driplines in each plot beginning at approximately 30 m from the plot inlet (i.e., roughly a section in the center of the 90 m length). This was accomplished using a tractor-mounted V-blade ditcher that removed the soil overburden within 5 to 7 cm of the dripline depth (Fig. 4). The dripline was then manually removed by gently tugging the dripline from the remaining soil (Fig. 5). These dripline lengths were carefully folded into 115 L plastic bags for storage until emitter performance measurements were conducted in the laboratory. Immediately prior to laboratory measurements the remaining surface soil residues were carefully removed with a wet sponge and clean water. A series of up to 6 of the total of 23 driplines could be mounted at one time on the laboratory test bench for emitter discharge measurements (Fig. 6). An approximately 9 m section of the 20 m that had been excavated was randomly selected for performance measurements. This is equivalent to 30 contiguous emitters provided that all emitters were functioning. In a few cases, a random split in the dripline crease related to the overall SDI system failure necessitated a repair connection which decreased the emitters by one for each repair. Water was collected for a 20 minute period at both 55.2 and 68.9 kPa before volume determinations were made from mass measurements on an electronic scale. Both sets of results at the different pressures were normalized to the design pressure of 68.9 kPa.

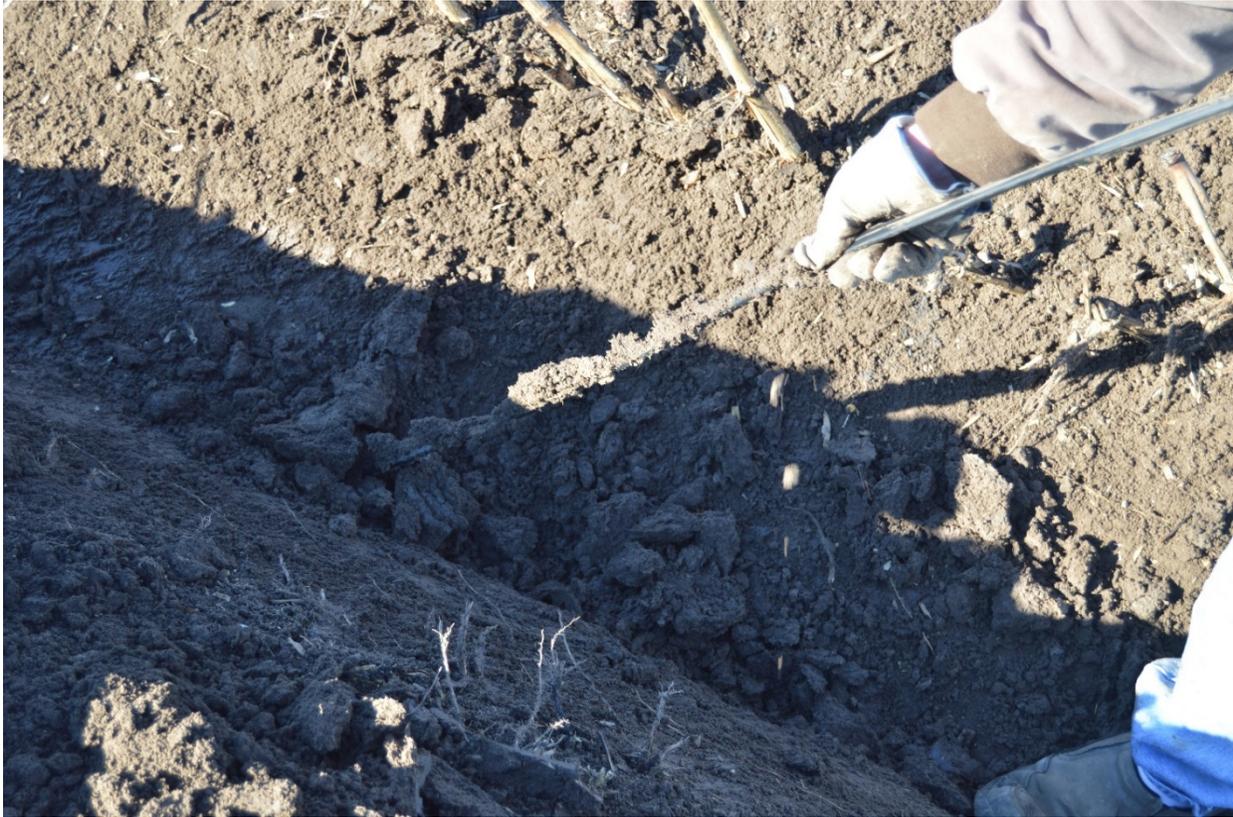
Figure 5. Careful extrication of the dripline from the remaining 5 to 7 cm of soil overburden.

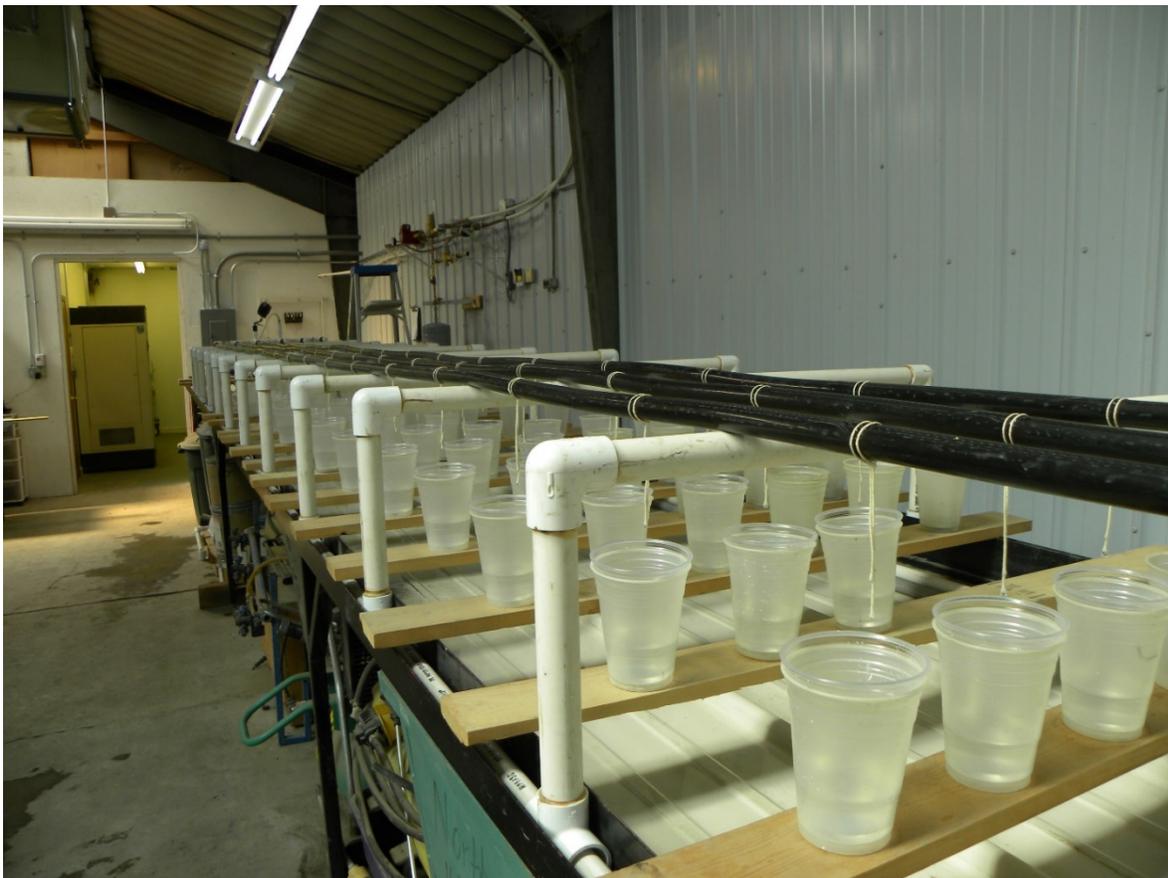
Figure 6. Laboratory bench arrangement for measuring emitter discharge from 30 contiguous emitters.
