# EVALUATION OF POLYETHYLENE SUBSURFACE DRIP IRRIGATION DRIPLINES AFTER 26 YEARS OF SERVICE IN A CORN FIELD IN NORTHWESTERN KANSAS

**Adriana Velasquez, Mark Jablonka, Freddie Lamm, Eddy Garcia-Meitin**  
The Dow Chemical Company / KSU Northwest Research Extension Center

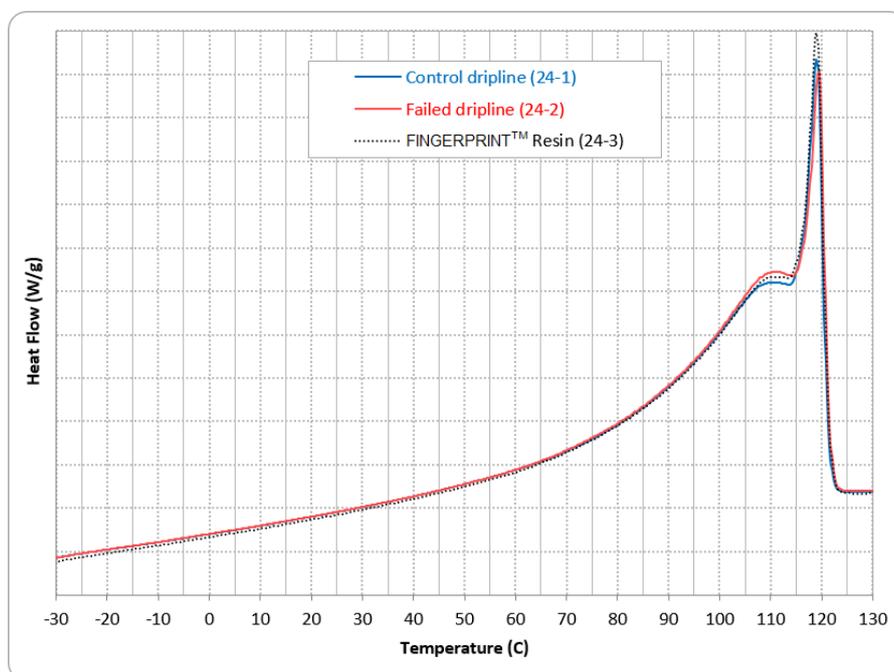
**Figure 3. DSC Second Heat Melting Curve Comparison.**

Figure 3 contains a plot of the DSC second heat melting curve comparing the control dripline, failed dripline and the FINGERPRINT™ resin. This plot illustrates the equivalent thermal characteristics of all three materials.

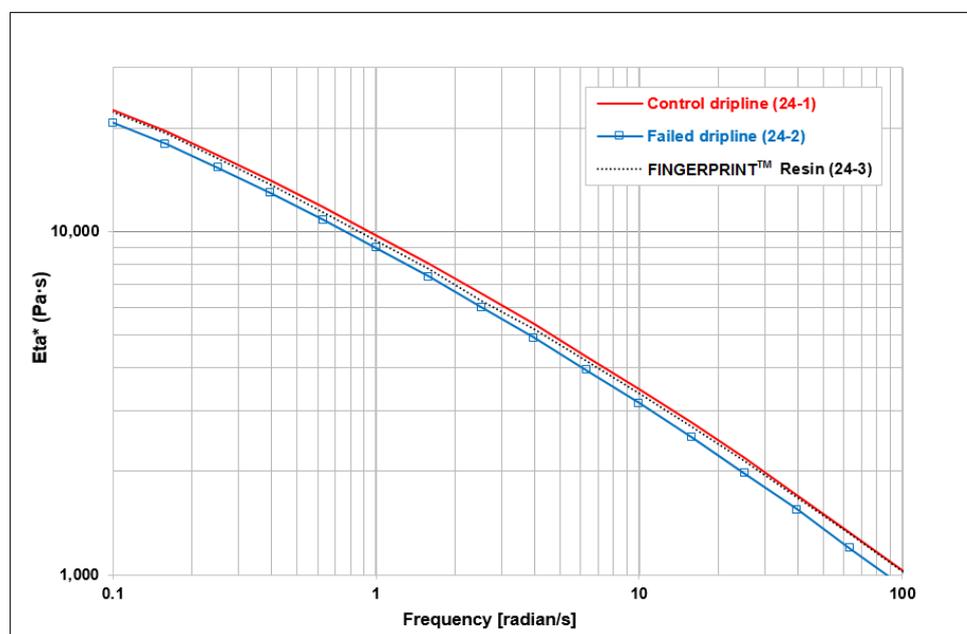
**Figure 4. DMS Viscosity Overlay at 190°C.**

DMS rheology was performed on the materials and the viscosity curves are summarized in Figure 4. The overall viscosity of the material in the failed dripline (24-2) is about 7% lower than FINGERPRINT™ in the low shear region and about 10% lower in the high shear region. Typically the viscosity of carbon black containing polyethylene is greater than polyethylene

absent of carbon black. The control dripline (24-1) which was never put in service has a viscosity profile very close to that of FINGERPRINT™. This difference is likely due to normal variation during the process of extruding the dripline, and doesn't necessarily indicate that there is degradation by chain scission.
